MARINE SURVEYOR

REPORT OF AN INSURANCE SURVEY CARRIED OUT ON THE VESSEL:

'Vanessa', 1953, 53' twin screw motor yacht.

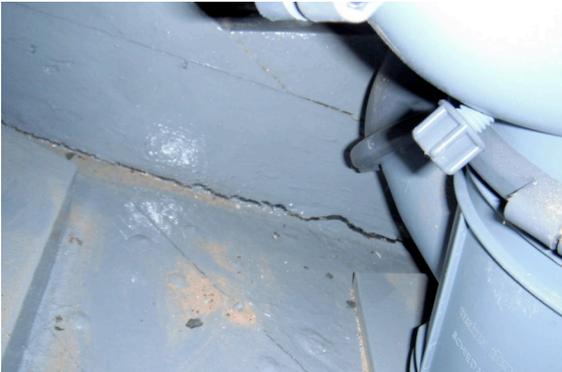
Most of these structures were in good order where seen with no signs of deterioration to the material and fastenings with the exception of a frame around midships in the engine space which has cracked away from the hull (shown), possibly where the hull planking has been loaded with the vessel

ashore. No damage was seen outside the hull but **this should be monitored when the vessel is launched for leaks or excessive movement (B)**.

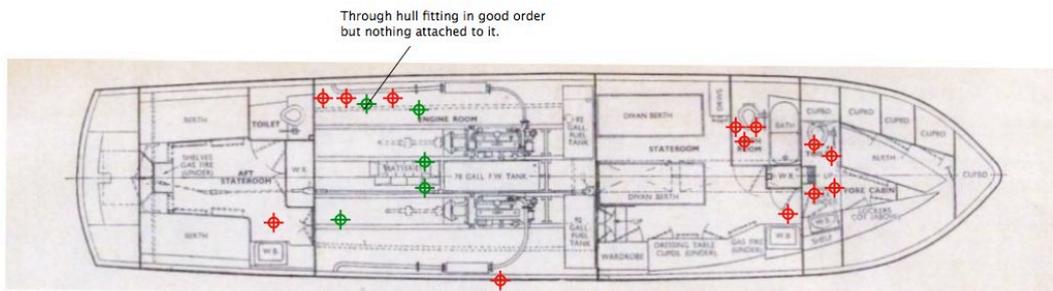
SKETCH TO SHOW POSITION OF SEA COCKS - NOTE THE NUMBER OF FITTINGS IS CORRECT BUT THEIR EXACT LOCATION MAY NOT BE SO CHECK THE AREAS MARKED UNTIL ALL ARE ACCOUNTED FOR.

The vessel is mostly fitted with bronze, tapered valve, type skin fittings, often called 'Blakes', although these particular ones were made by Simpson Laurence. On the first visit, several of were found to have been fastened with what were probably brass bolts. These had de-zincified over the years such that they could be easily broken. By the second visit, all suspect fittings had been removed and were in the process of being replaced.

- ◆ BLAKES TYPE SEA COCK SECURED WITH FOUR BOLTS. THESE TO BE DISMANTLED, BOLTS SECURING THEM TO HULL REPLACED WITH NEW BRONZE TAIL PIPES REPLACED AND REINSTALLED.
- ◆ OTHER SEACOCKS ALL FOUND SATISFACTORY.

At present only those marked in green on the above plan are in good condition and one of these (aft engine port) has no valve.

It is understood that all fittings will be made good before launch (A). This includes the valve and through hull being securely mounted, valves being easily accessible and moving freely, connecting hoses being secured with two stainless steel hose clips and the hoses being in good order and free from chafe sources, and any tail pipes (the copper pipes over which the hoses are secured on the older bronze fittings) being free of corrosion.

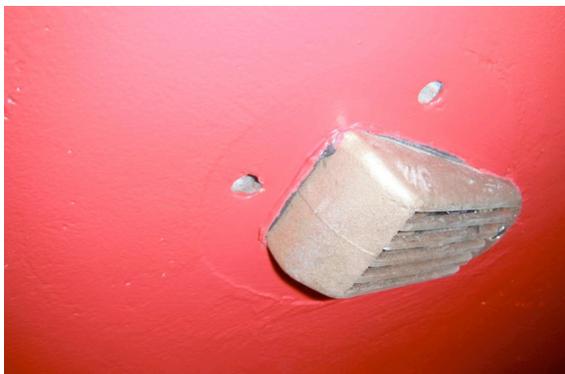
Some of the holes from the old skin fittings had not been filled (shown on engine water intake); these should be in order to prevent potential leaks and deterioration of the hull planking (B).

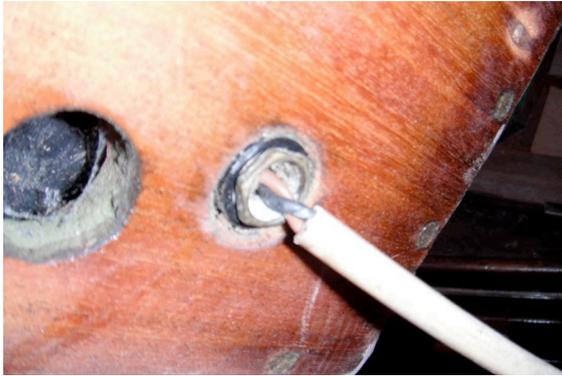
Not yet fitted although the side lights were seen loose.

Note the cable on one needs re-securing (shown).

To comply with regulations, the vessel should have separate side lights, a masthead steaming light and a stern light (A).
