“VANESSA”
GENTLEMANS MOTOR YACHT
MS E CRISP

SURVEY

Ref: IL1508

9th June 2010

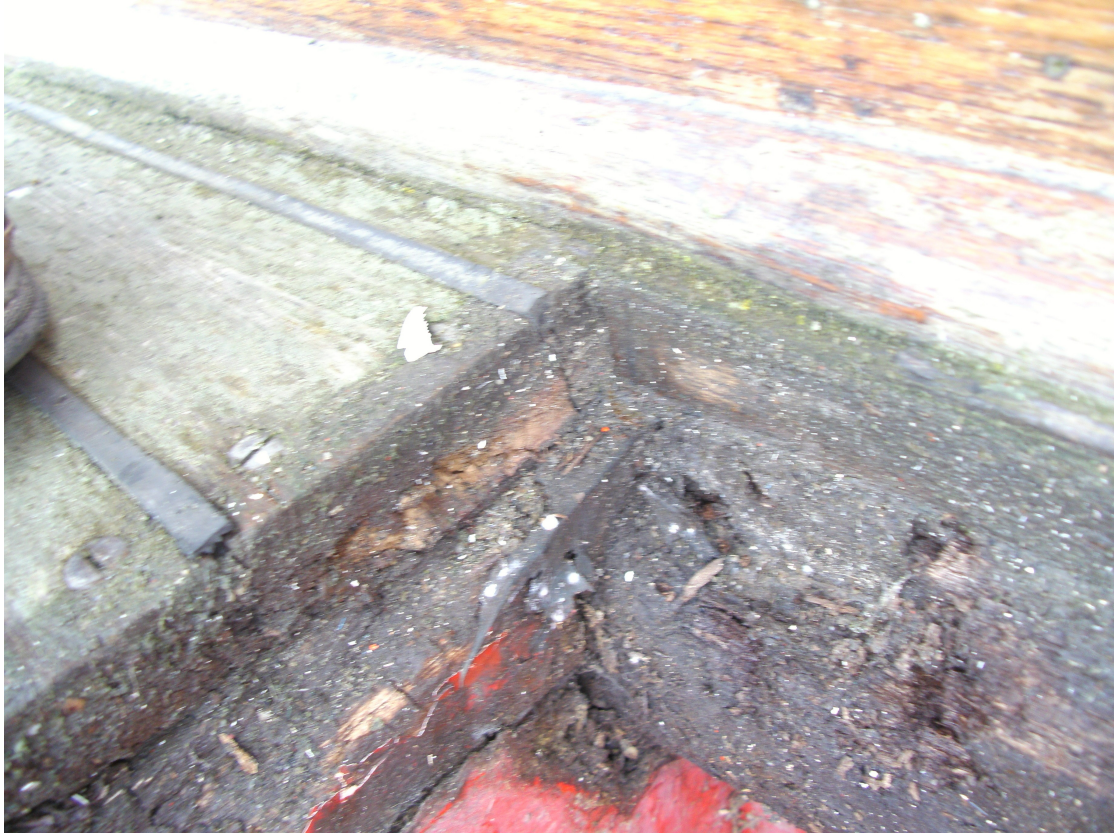
Gas locker top

The top frame work to this locker was rotten, the metal container for the gas bottles was extensively corroded and much of the top section had disintegrated.

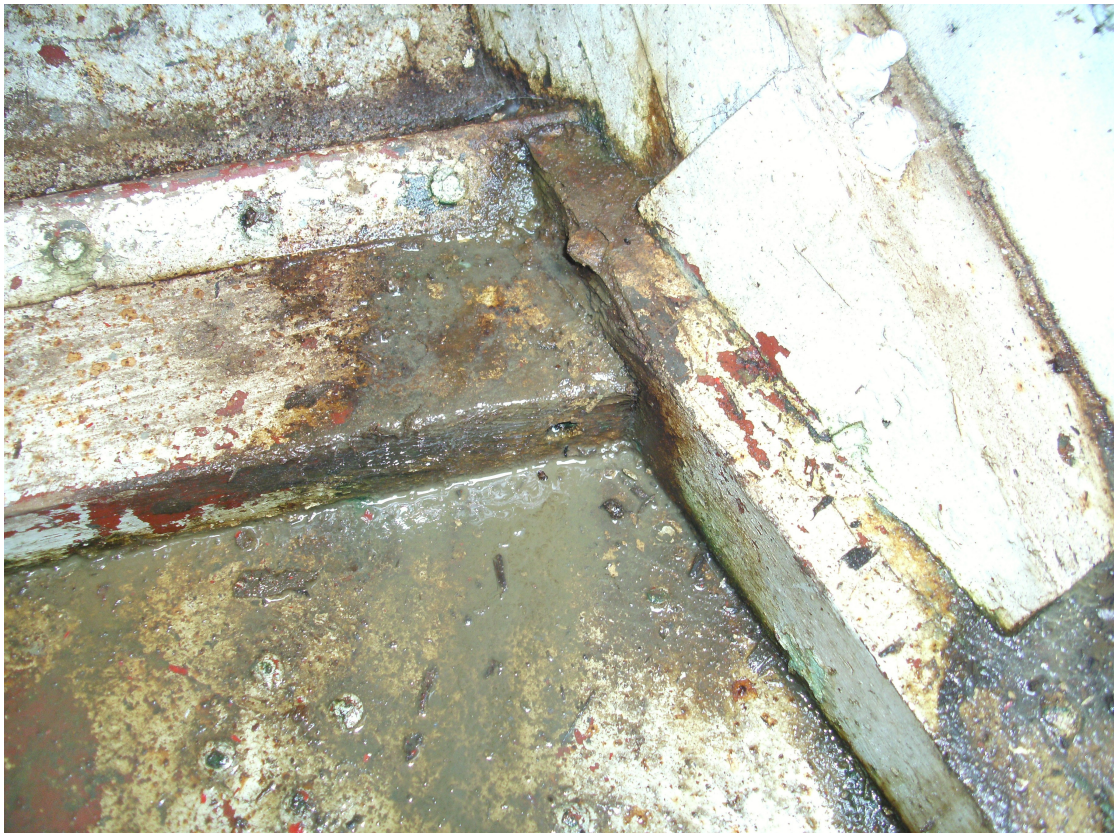
Lazarette transom starboard side

Some items were removed from the lazarette to allow access to the structure including loose floor boarding, it was found that on either side of the stern post water was entering the craft at an approximate rate of one litre a minute, also to the outer reaches of the transom water was entering the craft but at a slower rate.

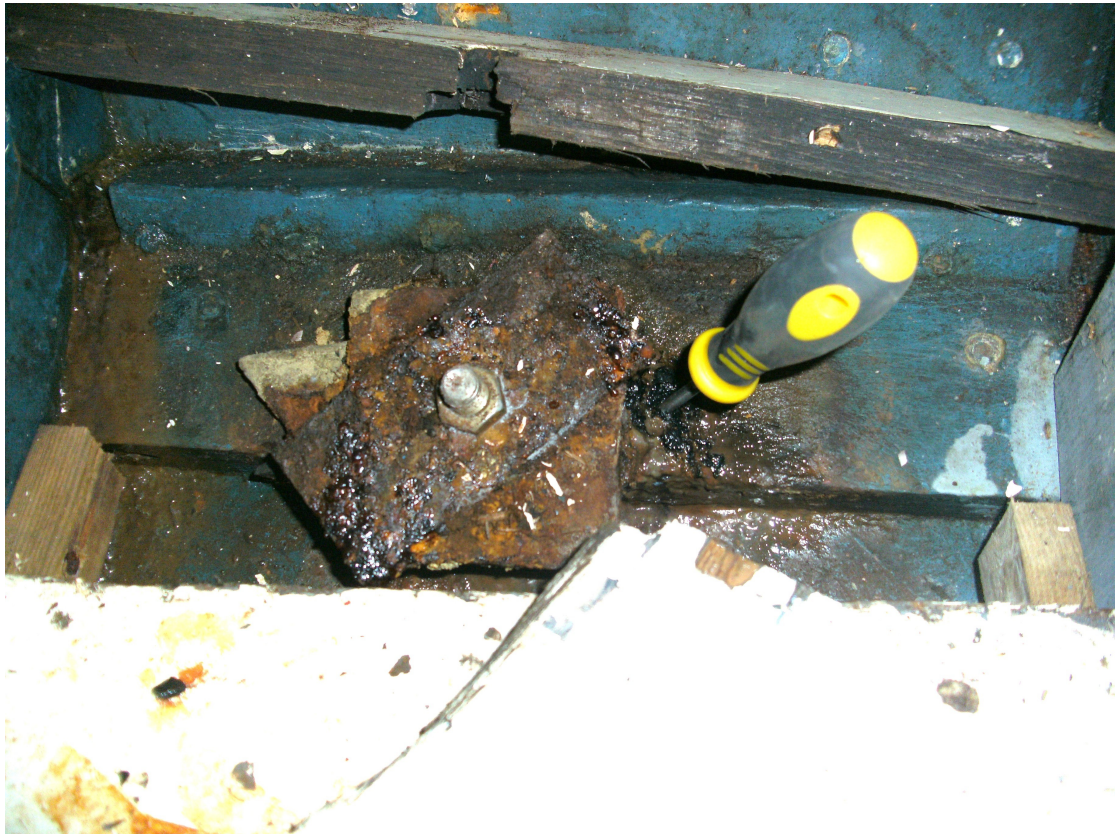
One section of the starboard longitudinal frame

The longitudinal outermost frame which has keel bolts protruding through which have been poorly shimmed.

This frame was found to have significant rot and was allowing water ingress around most of the bilge keel bolts.
